Home Inspection Report

Your Future Home

Inspected on Thu, Jun 28 2018 at 2:24 PM

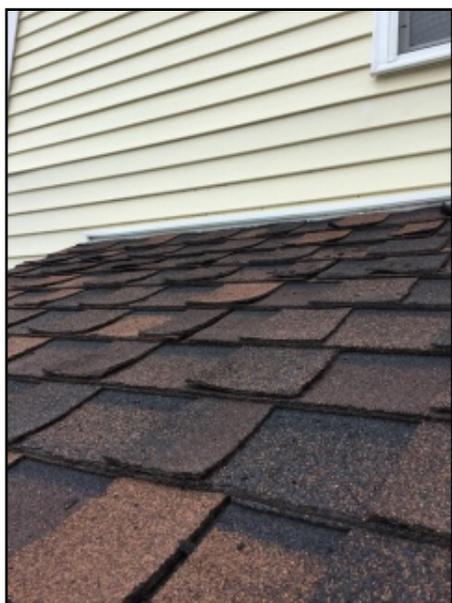
Figure 1-1

Portions of the roof had accelerated deterioration because of a missing gutter. Water falling on roof was causing mechanical damage of shingles. Granular run off can be seen in lower gutter system. Small areas of uplift on upper portion of roof was visible. Seller states architectural shingles to be 9 years old. Architectural shingles have an expected lifespan of 30-35 years. Recommend repairing damaged shingles over entrance way and replacing missing gutter system. Monitoring shingle roof annually is recommended to maintain the shingles water shedding function. Portions of the shingle roof were not visible and not inspected.

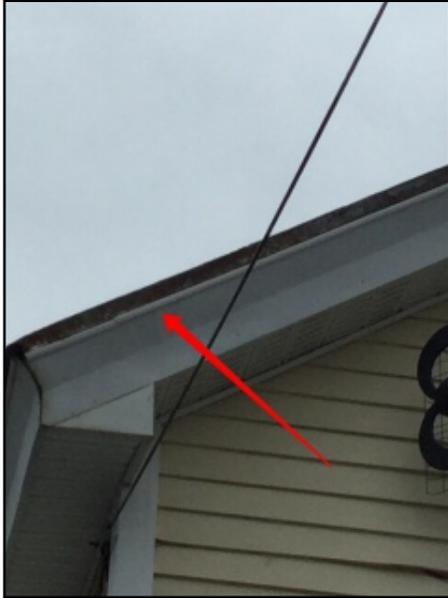
Figure 2-1

Comment 2:
Small areas of rust on metal roof flashing. Recommend monitoring annually.

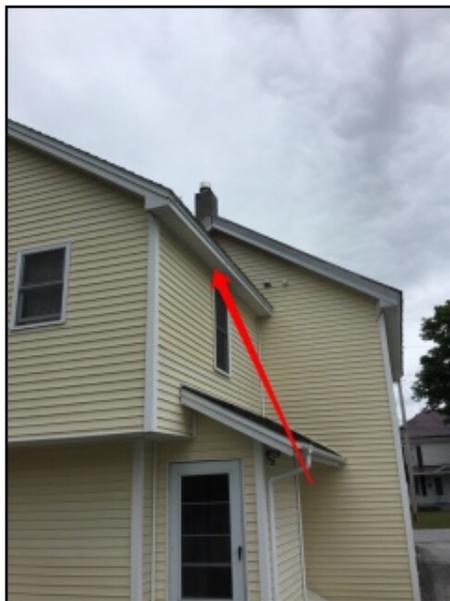
Figure 3-1

Missing gutter system. Replacing missing gutter system is recommended to avoid mechanical damage of lower roof from falling water.

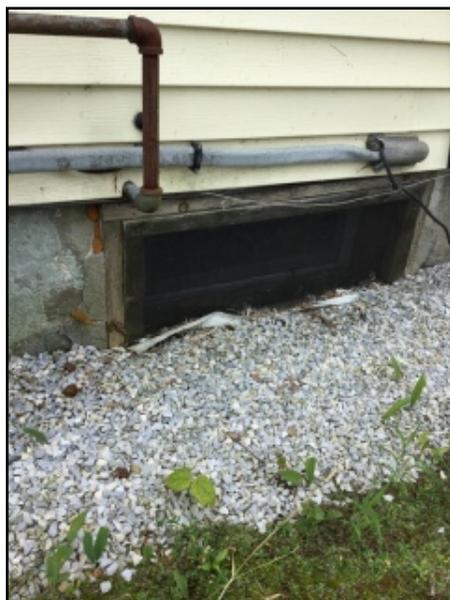
Figure 4-1

**Comment 4:**
Recommend monitoring windows located near grade for water intrusion.
Recommend adding window well covering.

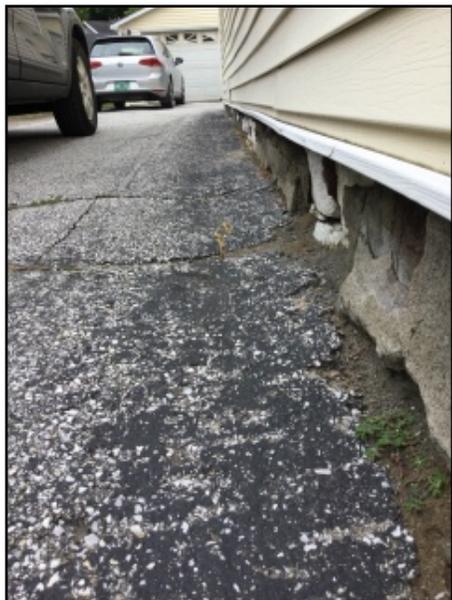
Figure 5-1

Stone foundation was well maintained. Showing small areas of spalling. Maintaining foundation throughout life of house is important to prevent water intrusion and degradation. Recommend monitoring.

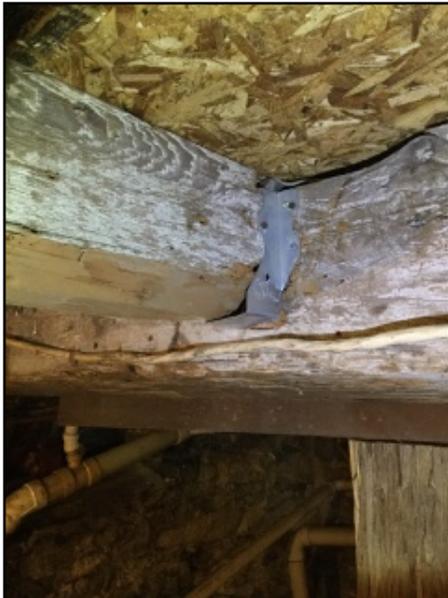
Figure 6-1

Beam jacks were improperly secured at time of inspection. Beams were improperly notched in mid-third of span. Properly installed columns, beam jacks, associated hardware, and supports for notching is recommended to ensure and maintain long term structural integrity of structure. No obvious signs of structural movement was seen throughout house. A comprehensive structural analysis is outside the scope of a inspection and buyer should seek further evaluation. Recommend correction of posts and columns to a manufactured and engineered product and installing to manufacturers specifications. Installation by professional installer is recommended.

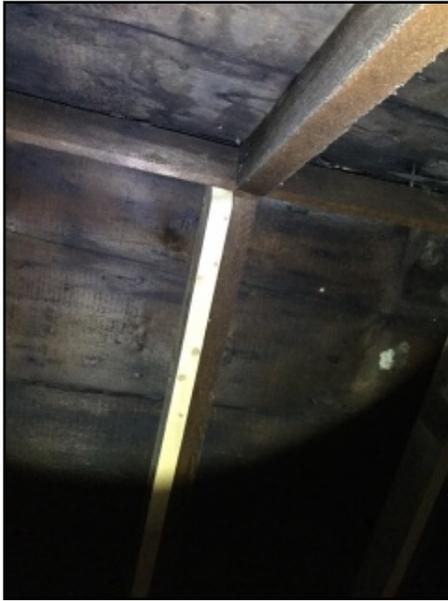
Figure 7-1

Added support has been fastened to rafters. This is not a defect but because of the structures age care should be taken to monitor roofing components throughout ownership of the home.

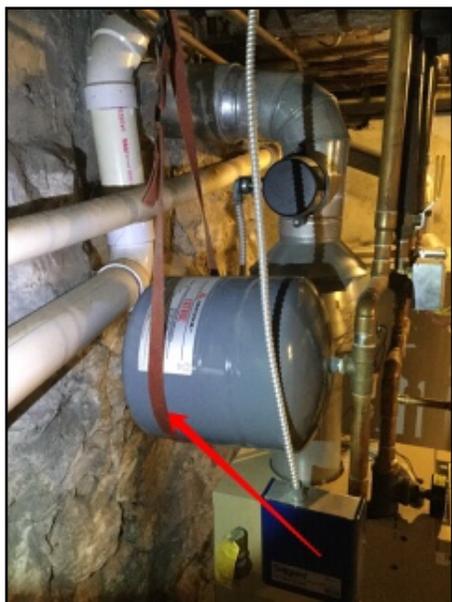
Figure 8-1

Improper installation of expansion tank was located on heating equipment. Improperly installed equipment can increase likelihood of component failure and reduce functionality. Correction by qualified plumber is recommended.

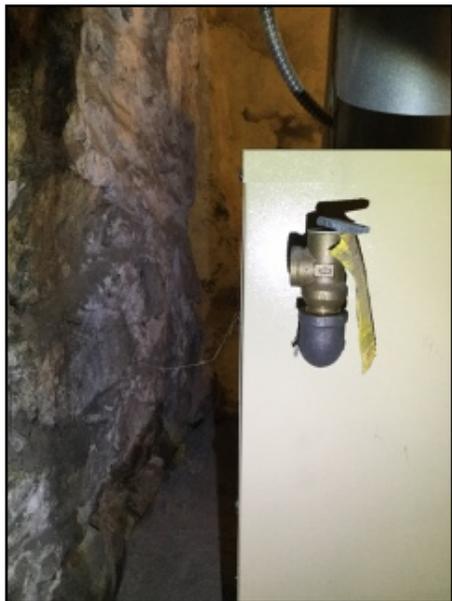
Figure 9-1

Discharge pipe was not installed on boiler relief valve at time of inspection. Discharge pipes are used to prevent the spray of scalding water from relief valves and should be installed to terminate no more than 6 inches from floor. Installation of discharge pipe by plumber is recommended.

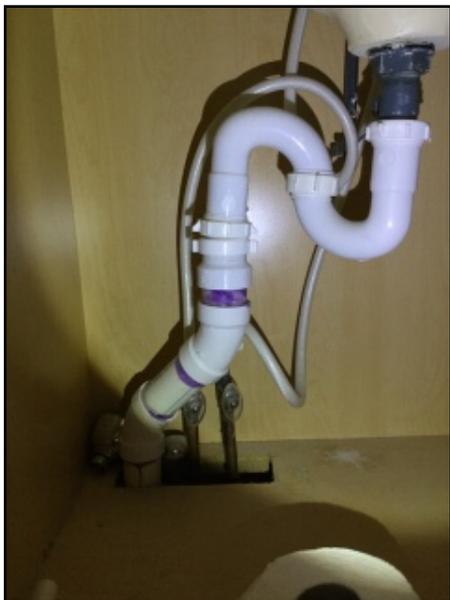
Figure 10-1

Second floor bathroom had improper S trap. S traps can self siphon and allow sewer gases to enter home. Correction of S trap by professional is recommended.

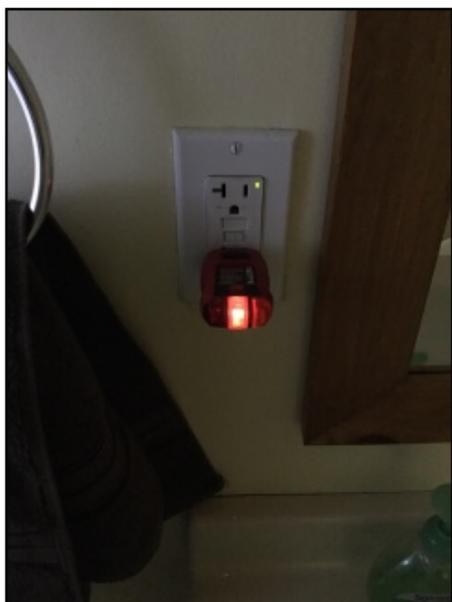
Figure 11-1

Missing or broken GFCI outlets were present at time of inspection in both bathrooms. GFCI outlets should be used in bathrooms, kitchen counters, the exterior outlets, and any location where water is present and can contact the outlet or devices being used by the outlet. Broken GFCI outlets will not protect from accidental electrical shock. Repair of GFCI outlets in required places to avoid injury by electrical shock is recommended

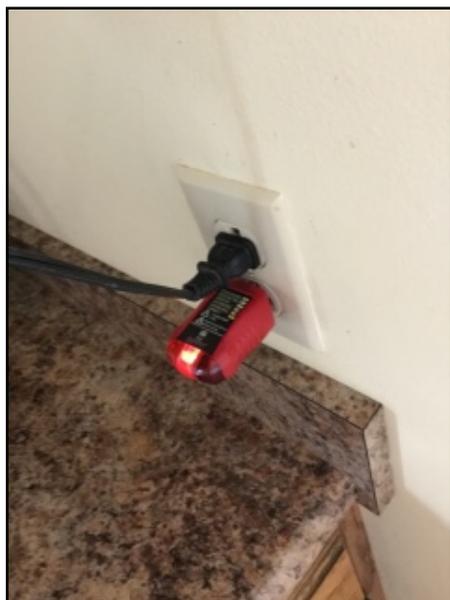
Figure 12-1

Open ground condition was present on several outlets at time of inspection. Proper grounding is important to avoid accidental electric shocks which can cause injury or death. Recommend further evaluation and correction by licensed electrician.

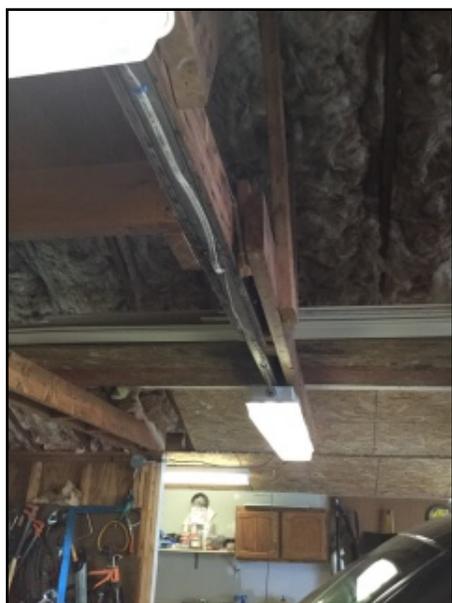
Figure 15-1

Sagging truss was obvious at time of inspection. Sagging ridge line was also obvious at time of inspection. Joist hangers or were not installed on all joists. Trusses were not engineered products and were installed using various pieces of particle board. Strong indications of a non professional installation due to previously stated observations. Failure of any truss component could result in a dangerous condition, injury, or damage to stored items. A comprehensive structural analysis is beyond the scope of a home inspection and further evaluation is recommended. Design of trusses and roof structure of garage should be evaluated by structural engineer or professional building contractor.
