Home Inspection Report

Your Future Home

Inspected on Thu, Jun 28 2018 at 2:24 PM

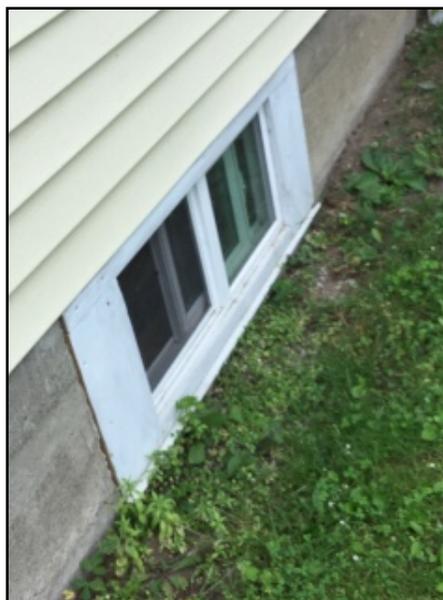
Figure 4-2

**Comment 4:**
Recommend monitoring windows located near grade for water intrusion.
Recommend adding window well covering.

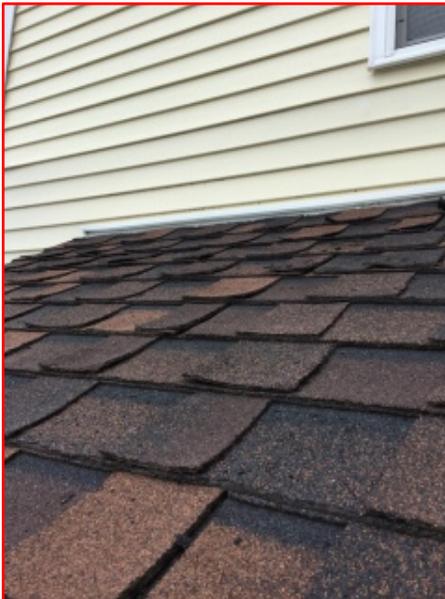
Figure 1-1

1) Portions of the roof had accelerated deterioration because of a missing gutter. Water falling on roof was causing mechanical damage of shingles. Granular run off can be seen in lower gutter system. Small areas of uplift on upper portion of roof was visible. Seller states architectural shingles to be 9 years old. Architectural shingles have an expected lifespan of 30-35 years. Recommend repairing damaged shingles over entrance way and replacing missing gutter system. Monitoring shingle roof annually is recommended to maintain the shingles water shedding function. Portions of the shingle roof were not visible and not inspected.

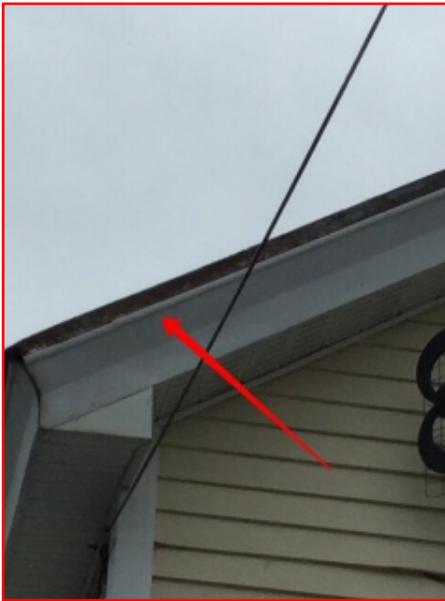
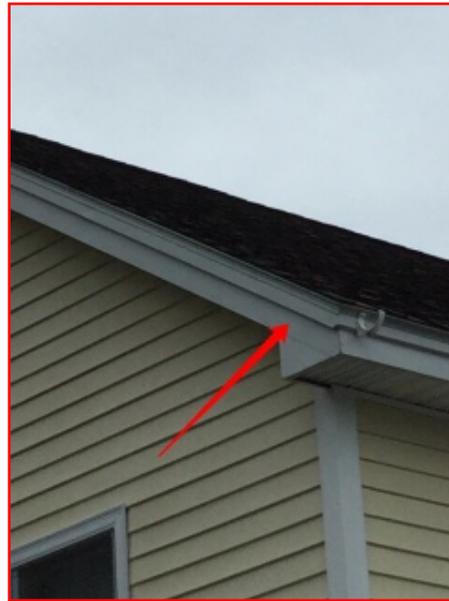
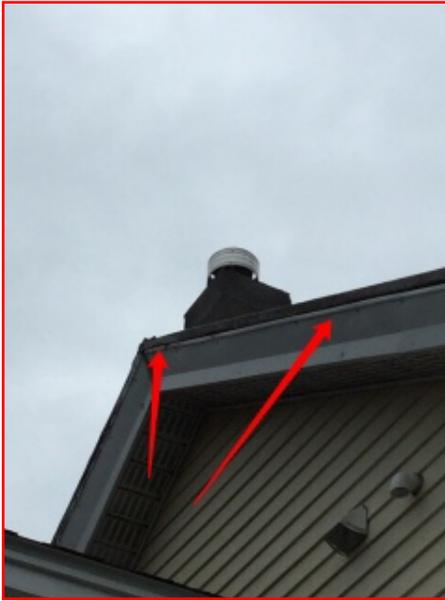
2) Small areas of rust on metal roof flashing. Recommend monitoring annually.

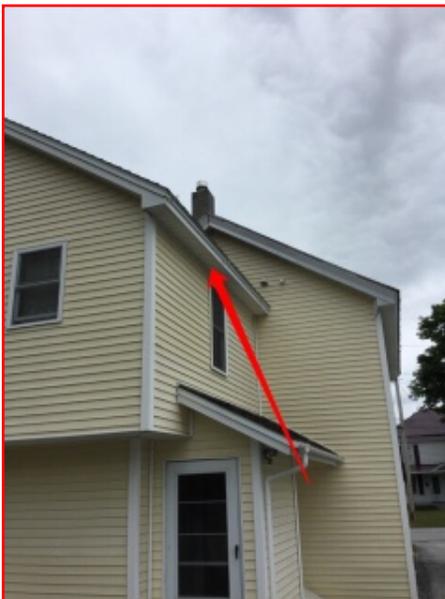
Figure 3-1

3) Missing gutter system. Replacing missing gutter system is recommended to avoid mechanical damage of lower roof from falling water.

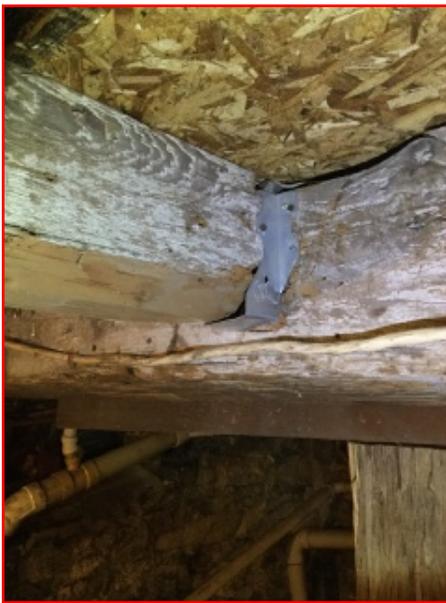
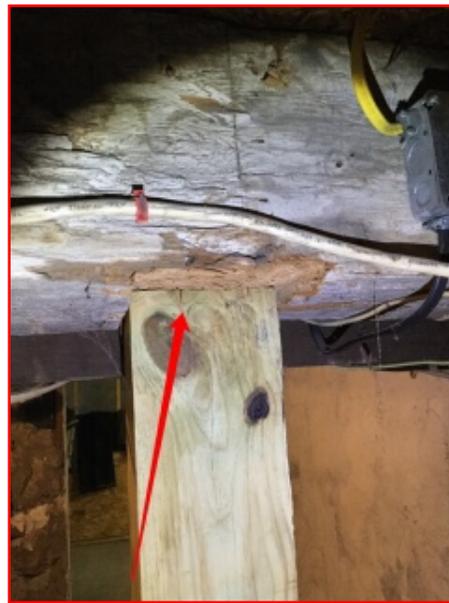
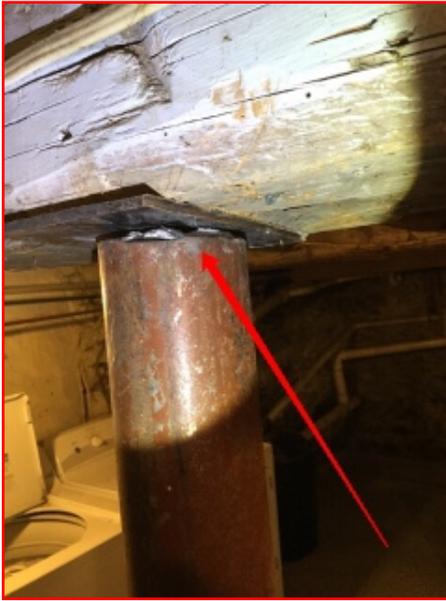
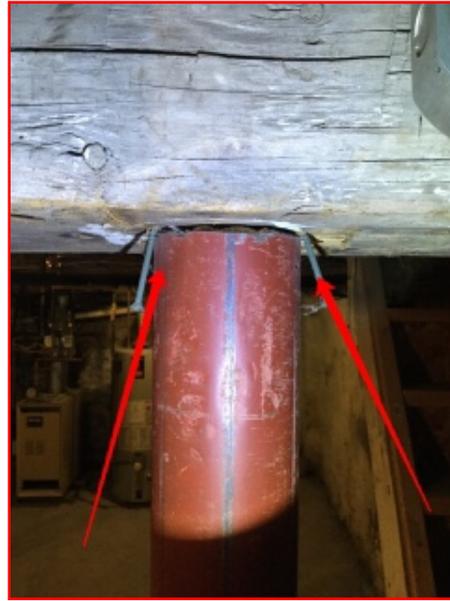
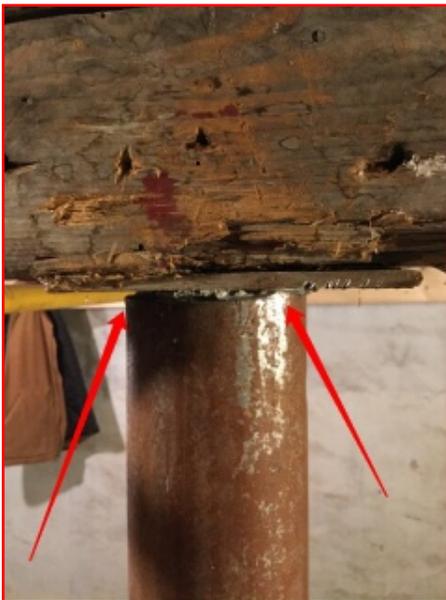
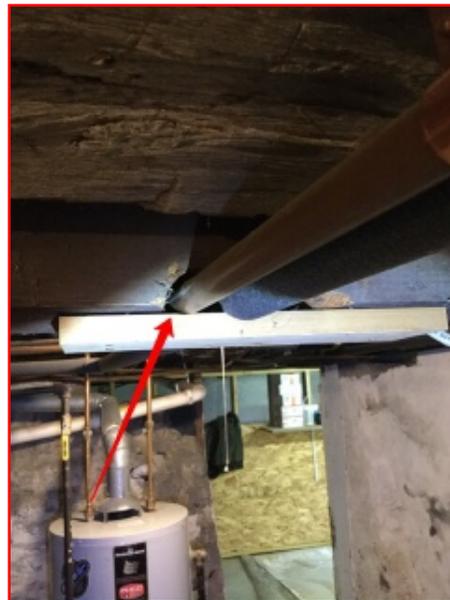
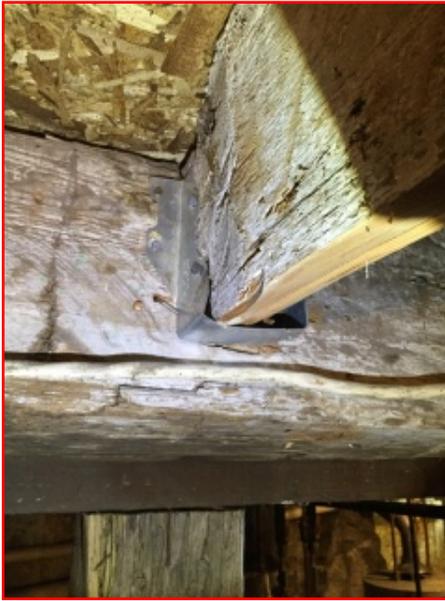
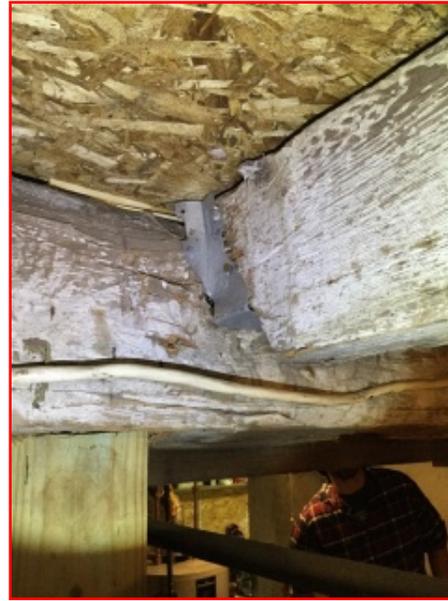
4) Beam jacks were improperly secured at time of inspection. Beams were improperly notched in mid-third of span. Properly installed columns, beam jacks, associated hardware, and supports for notching is recommended to ensure and maintain long term structural integrity of structure. No obvious signs of structural movement was seen throughout house. A comprehensive structural analysis is outside the scope of a inspection and buyer should seek further evaluation. Recommend correction of posts and columns to a manufactured and engineered product and installing to manufacturers specifications. Installation by professional installer is recommended.

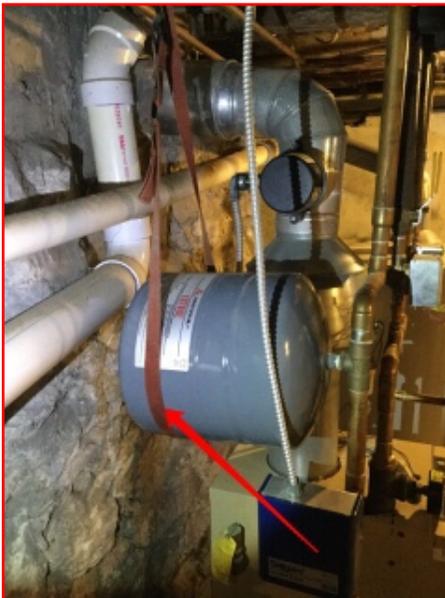
Figure 8-1

5) Improper installation of expansion tank was located on heating equipment. Improperly installed equipment can increase likelihood of component failure and reduce functionality. Correction by qualified plumber is recommended.

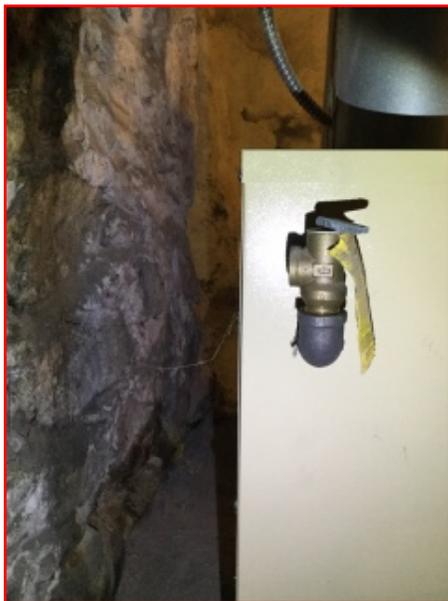
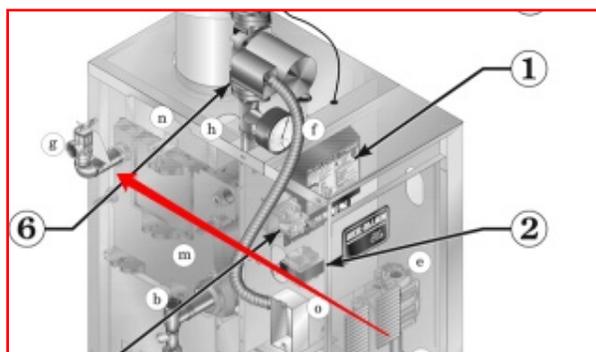
6) Discharge pipe was not installed on boiler relief valve at time of inspection. Discharge pipes are used to prevent the spray of scalding water from relief valves and should be installed to terminate no more than 6 inches from floor. Installation of discharge pipe by plumber is recommended.

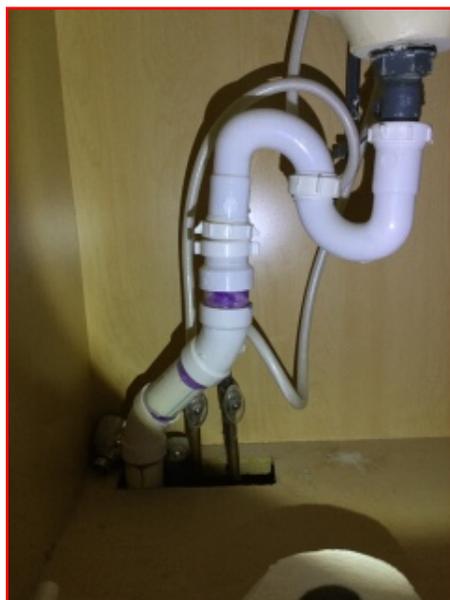
Figure 10-1

7) Second floor bathroom had improper S trap. S traps can self siphon and allow sewer gases to enter home. Correction of S trap by professional is recommended.

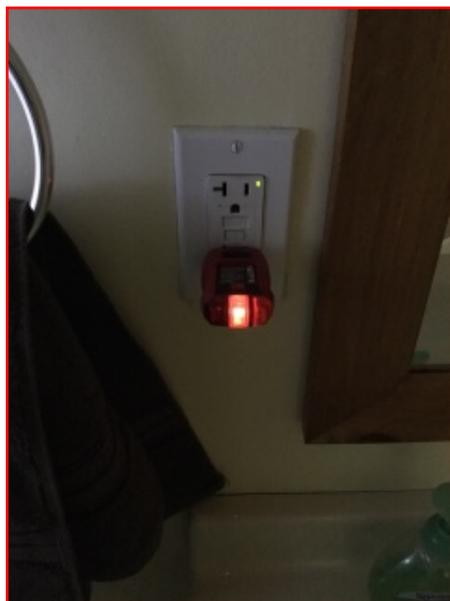
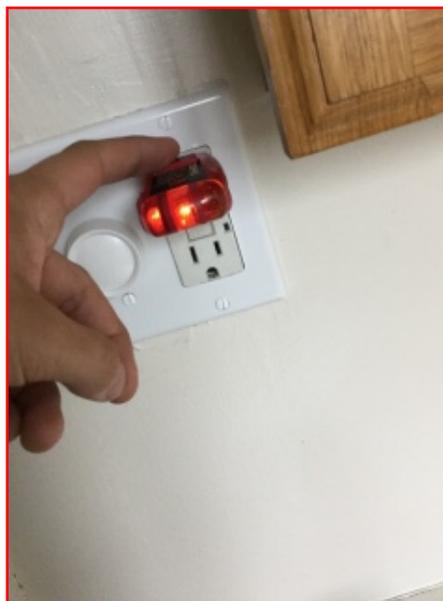
8) Missing or broken GFCI outlets were present at time of inspection in both bathrooms. GFCI outlets should be used in bathrooms, kitchen counters, the exterior outlets, and any location where water is present and can contact the outlet or devices being used by the outlet. Broken GFCI outlets will not protect from accidental electrical shock. Repair of GFCI outlets in required places to avoid injury by electrical shock is recommended

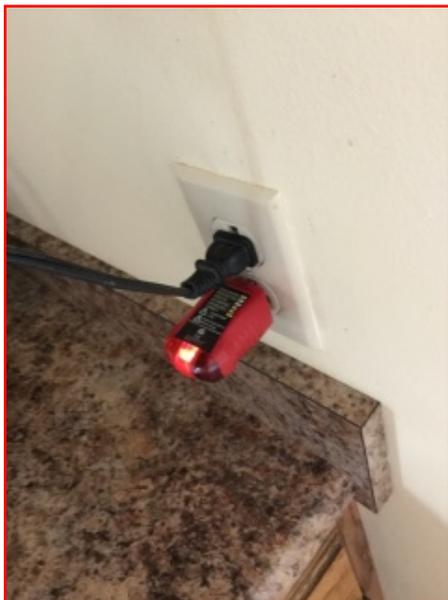
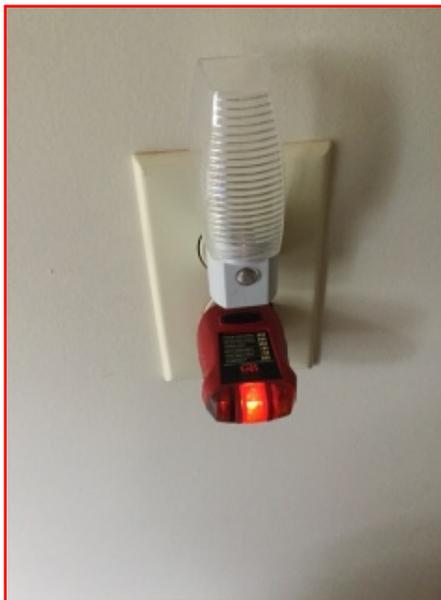
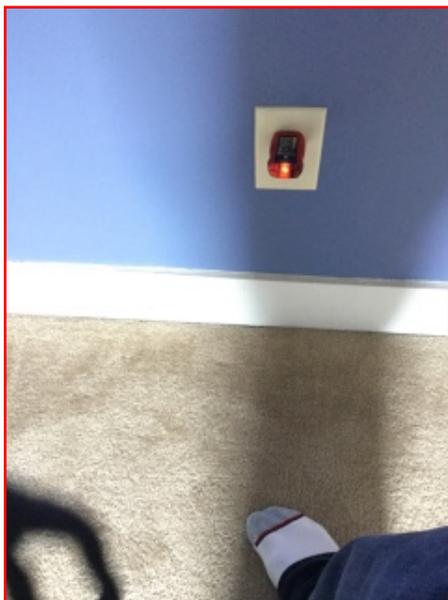
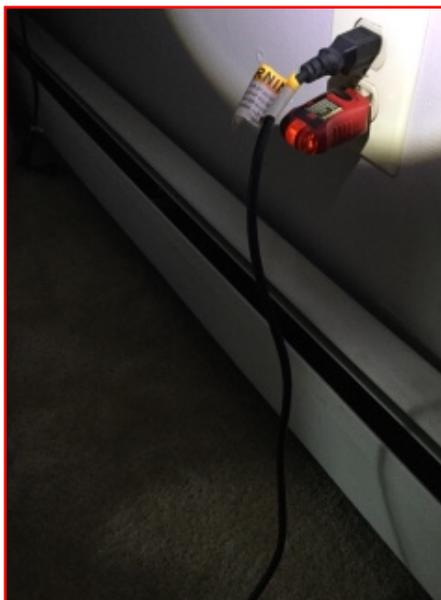
9) Open ground condition was present on several outlets at time of inspection. Proper grounding is important to avoid accidental electric shocks which can cause injury or death. Recommend further evaluation and correction by licensed electrician.

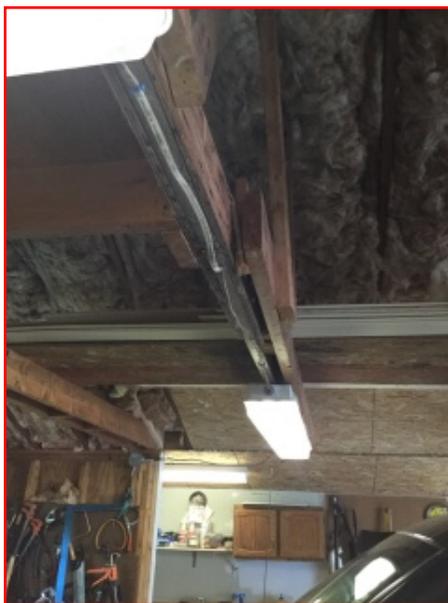
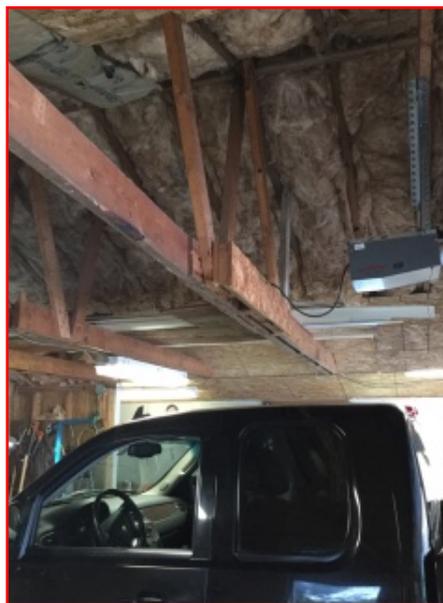
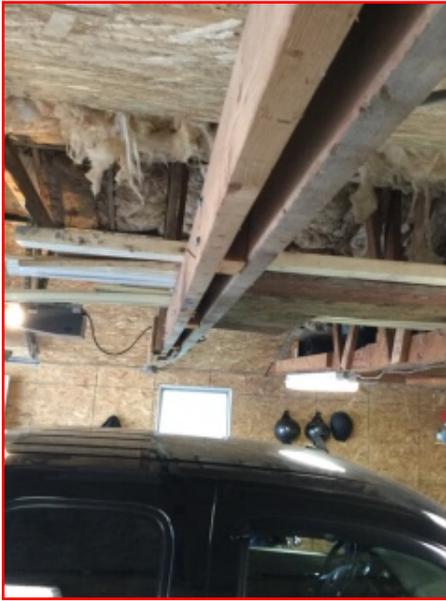
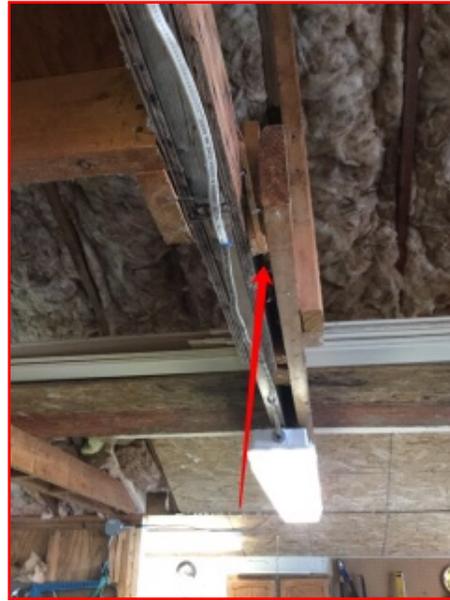
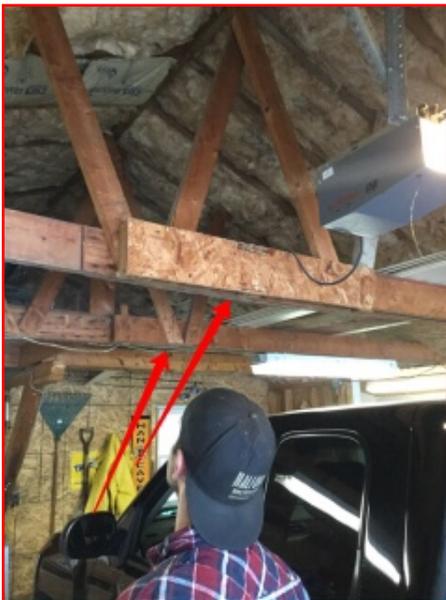
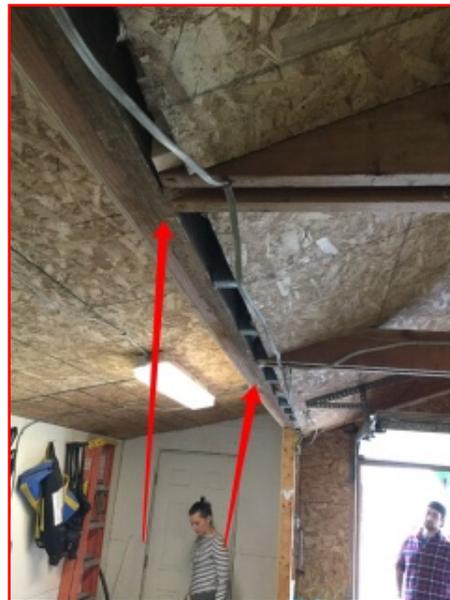
12) Sagging truss was obvious at time of inspection. Sagging ridge line was also obvious at time of inspection. Joist hangers or were not installed on all joists. Trusses were not engineered products and were installed using various pieces of particle board. Strong indications of a non professional installation due to previously stated observations. Failure of any truss component could result in a dangerous condition, injury, or damage to stored items. A comprehensive structural analysis is beyond the scope of a home inspection and further evaluation is recommended. Design of trusses and roof structure of garage should be evaluated by structural engineer or professional building contractor.
